SAM SITE CONSTRUCTION CUBA

Attachment to N- 8458/74
3 May 1974
Page 1 of 2
Copy 1

SAM SITE CONSTRUCTION
CUBA

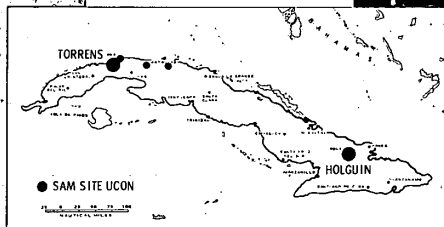
TORRENS SAM SITE
22-57-25N 082-26-52W

HOLGUIN SAM SITE SE
20-48-30N 076-13-07W

LAUNCH POSITION
CENTRAL GUIDANCE AREA

**MISSILE HOLD
REVTMENT**

Torrens SAM Site consists of six launch revetments around a rectangular shaped cleared area. The drive through roads at the launch positions are not yet discernible. The site is in an

early stage of construction. A central guidance area is also under construction at this site.

Holguin SAM Site SE consists of three drive-through missile launch revetments and two drive-through missile-hold revetments were under construction. A central guidance area is also under construction. Vegetation has been cleared for the three remaining launch positions.
